WHITE PAPER:

IN-LINE TAPPING IN THE DATA CENTER

WIRESHARK HEROES SERIES

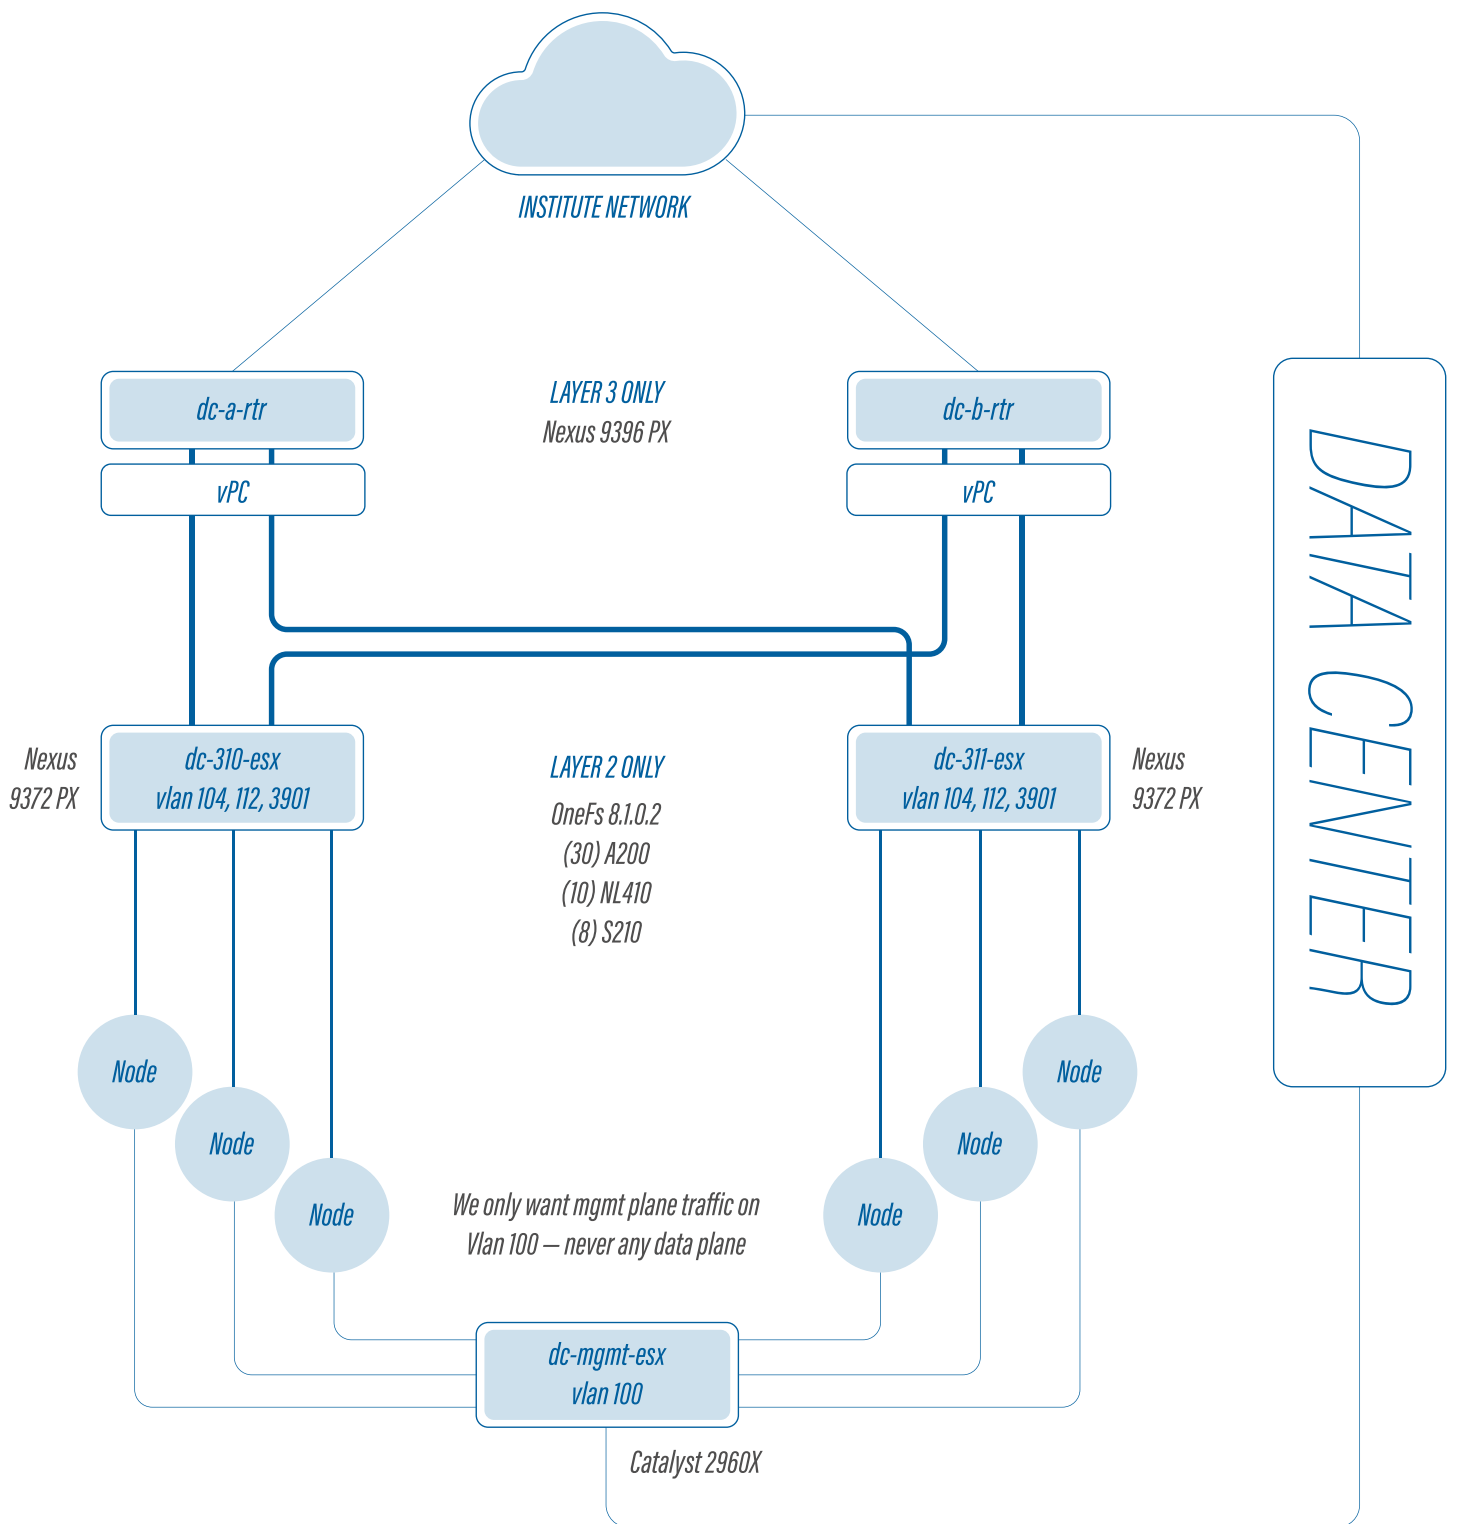
LEGEND

Vlan 100 = 10.80.100.0/22	Mgmt only
Vlan 104 = 10.80.104.0/22	Legacy Data Plane (SMB & NFS)
Vlan 112 = 10.80.112.0/22	New Data Plane (SMB & NFS)
Vlan 3901 = 172.20.0.0/16	HPC Data Plane (NFS only)

<i>1G Ethernet</i>	
<i>10G Ethernet</i>	
<i>40G Ethernet</i>

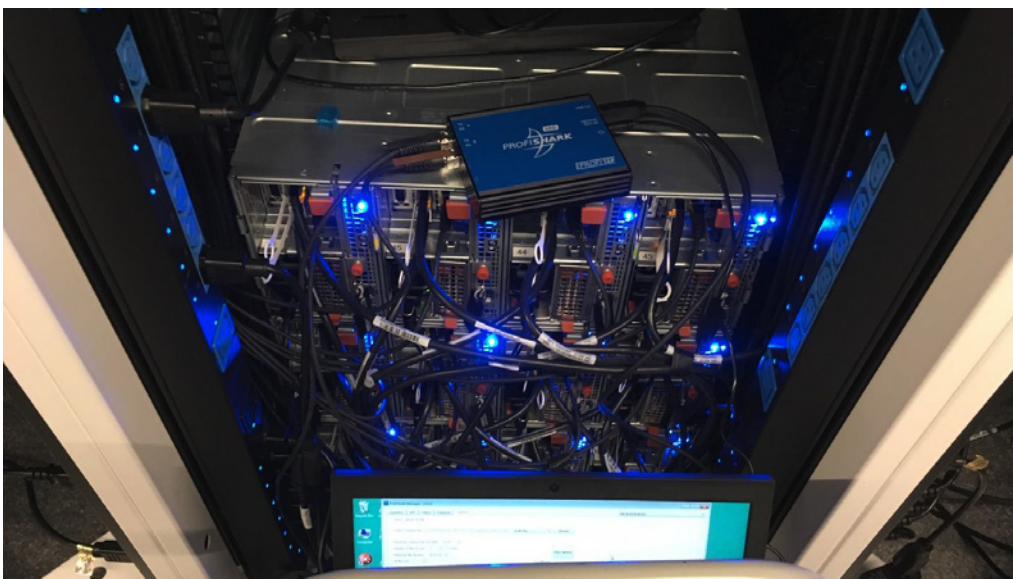
Next, we see the blue ProfiShark 10G unit sitting in top of a stack of Isilon Nodes, operated by the laptop visible at the bottom.

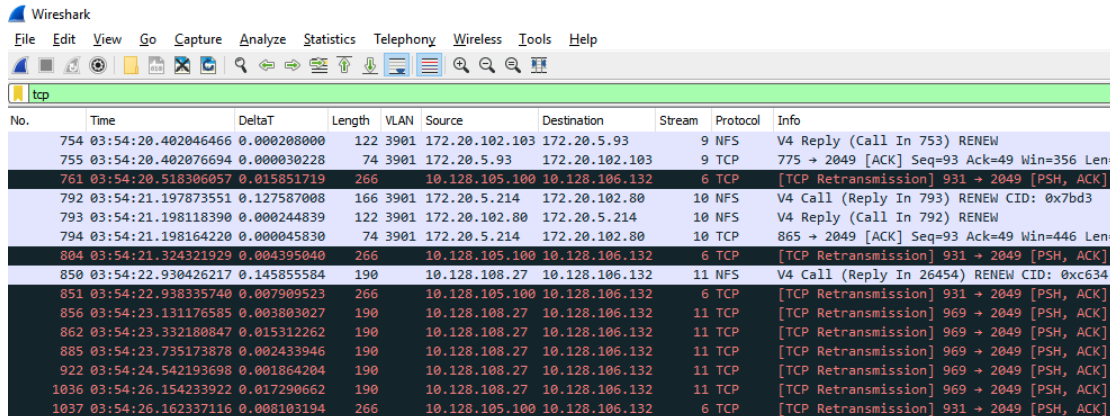
So the Node is tagging VLAN 104, 112, and 3901 frames, while the Switch is tagging only the latter two ... more specifically, the Switch is not tagging VLAN 104 frames. [If configured correctly, the Switch would have inserted '104' into the VLAN ID field into those 'TCP Retransmission' frames, see below.]

Wireshark interface showing a capture of network traffic. The packet list pane displays several packets, including NFS and TCP traffic. The packet details pane shows the structure of a TCP packet, including the 'Info' field which indicates a retransmission.

Aha! So, if the Node wants to tag VLAN 104 frames but the switch does not do so, then the Node is discarding incoming (untagged) frames. And that pretty well breaks things.

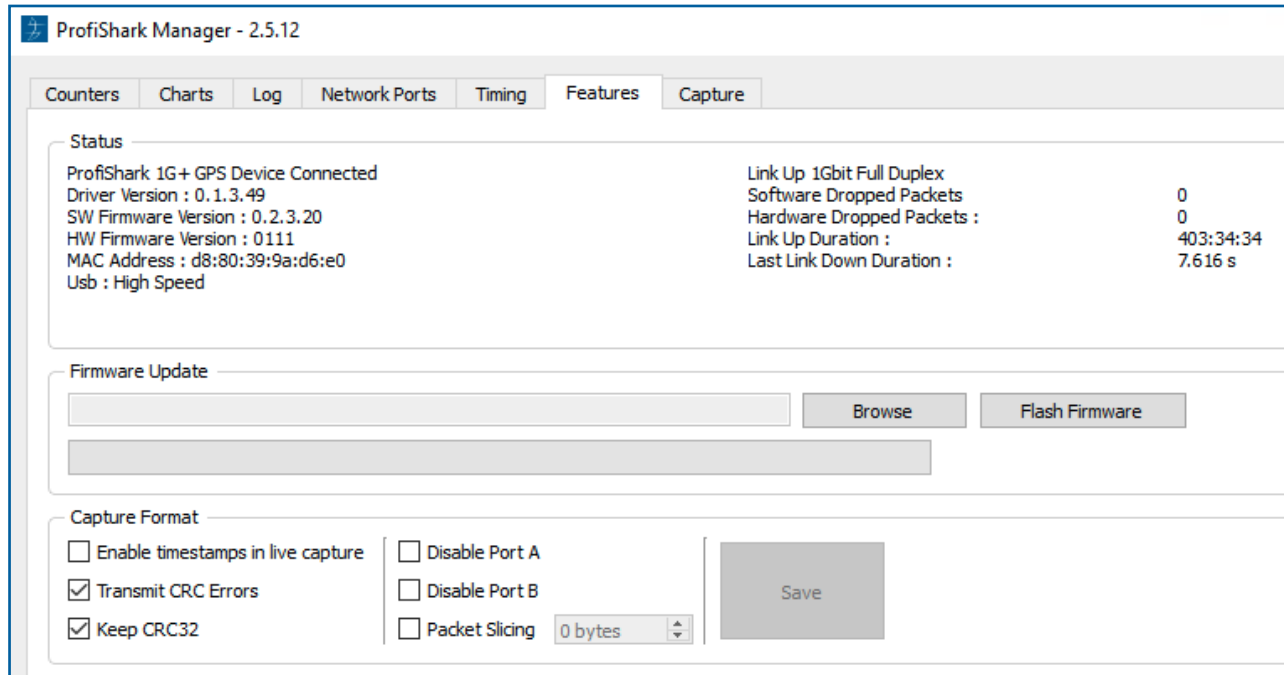
Features:

Optionally enable or disable hardware-level capture features.

The screenshot shows the 'Features' tab in ProfiShark Manager. It is divided into three sections: Status, Firmware Update, and Capture Format.

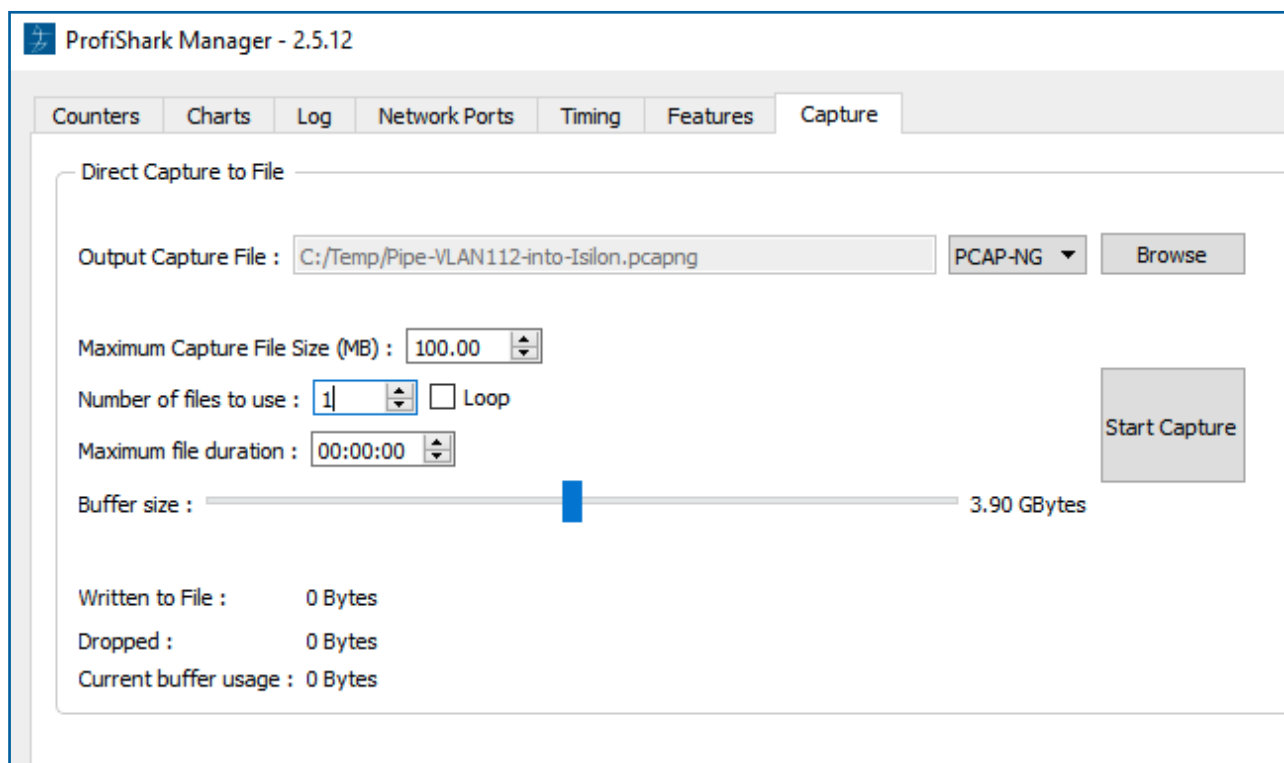
Captures:

And finally the Capture screen.

The screenshot shows the 'Capture' tab in ProfiShark Manager. It is titled 'Direct Capture to File' and contains the following settings:

- Output Capture File :** C:/Temp/Pipe-VLAN112-into-Isilon.pcapng (with a 'Browse' button)
- Format:** PCAP-NG (dropdown menu)
- Maximum Capture File Size (MB) :** 100.00 (dropdown menu)
- Number of files to use :** 1 (dropdown menu) with a 'Loop' checkbox (unchecked)
- Maximum file duration :** 00:00:00 (dropdown menu)
- Buffer size :** A slider set to approximately 1.5 GB, with a maximum of 3.90 GBytes.
- Start Capture:** A large button on the right side.
- Statistics:** Written to File : 0 Bytes, Dropped : 0 Bytes, Current buffer usage : 0 Bytes.

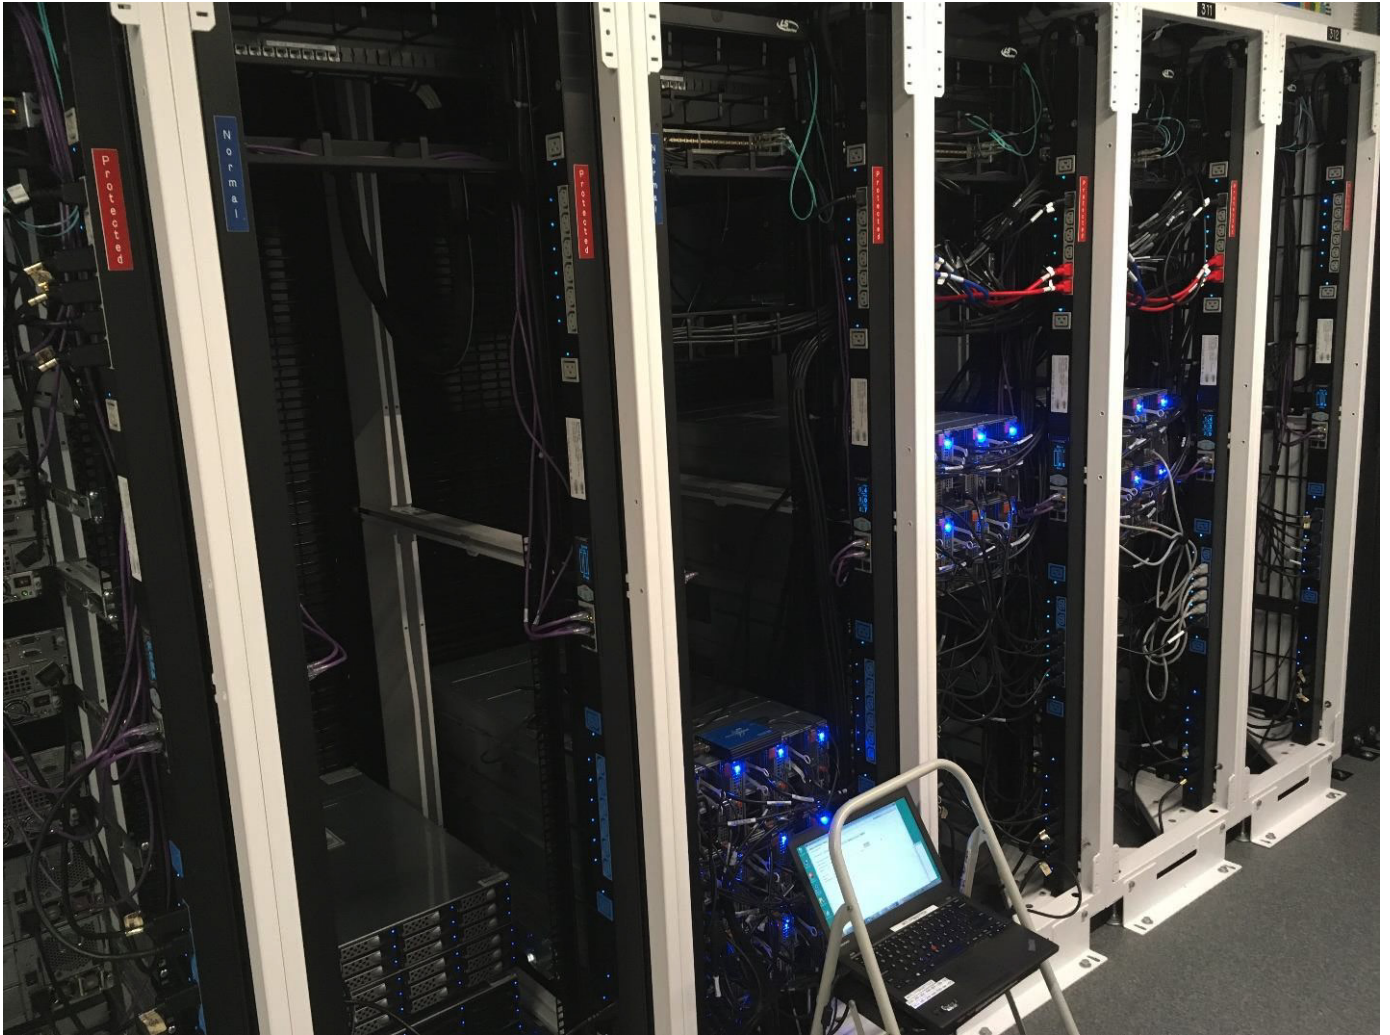
Isilon Row

Here we approach the row of Cabinets hosting the Isilon Storage System, with my laptop on a stool and the ProfiShark 10G barely visible above it. The Nexus 9372PX switches are minimally visible at the top of the Cabinets; the large blue LEDs mark the Generation 6 Isilon nodes; the Generation 5 nodes which populate most of these Cabinets aren't visible. And the small blue LEDs mark the vertical plug-strips providing power.

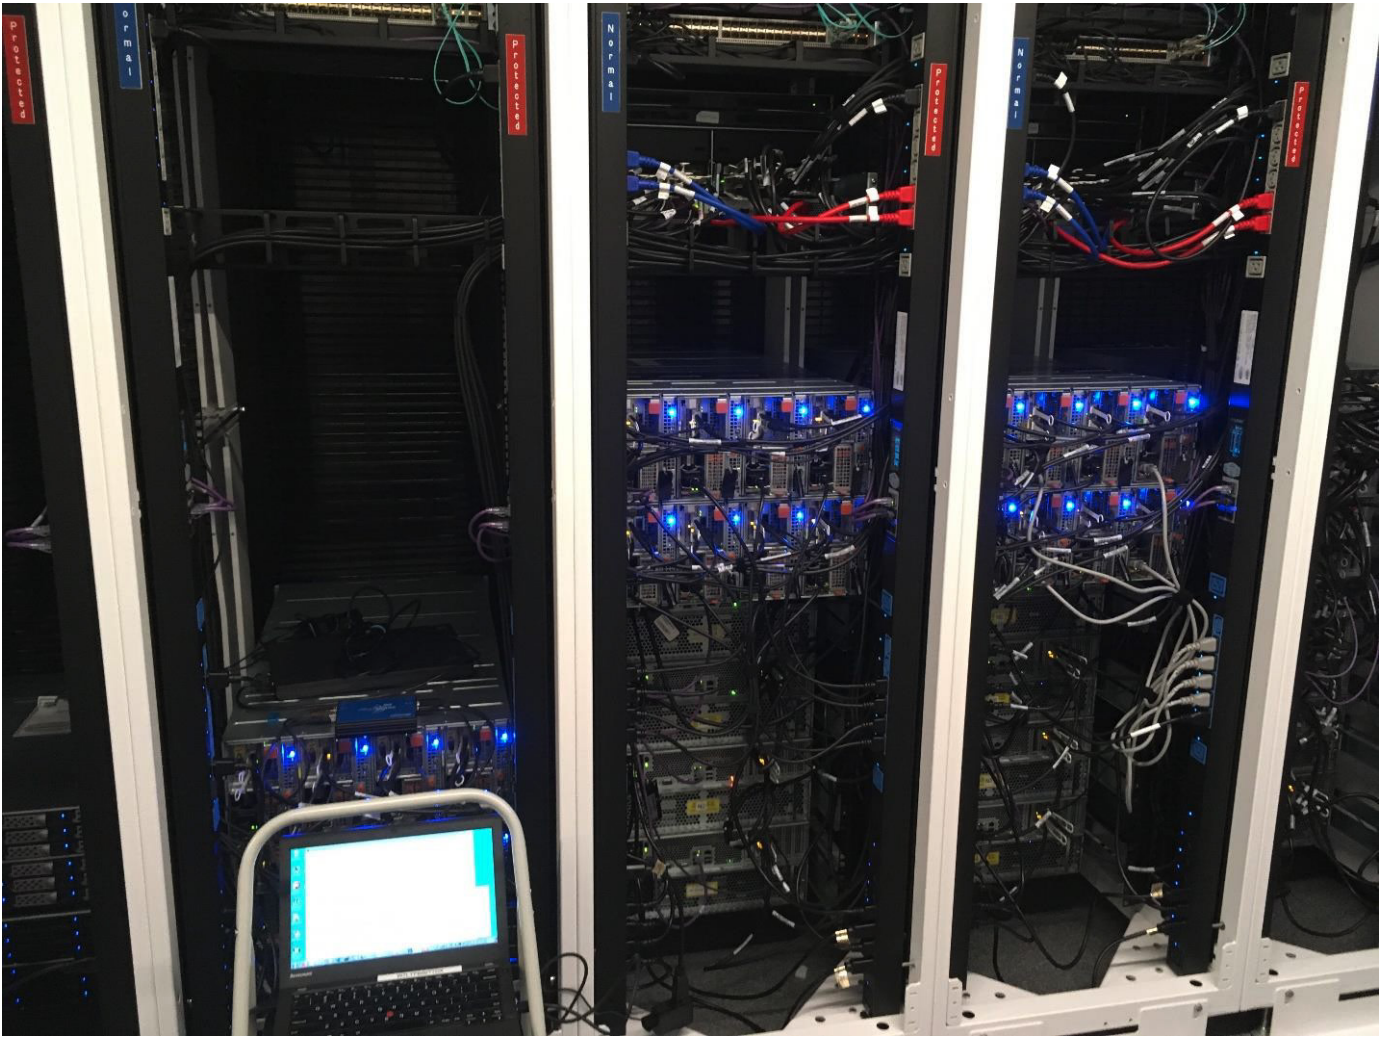
Isilon Cabinets

Walking closer to these Cabinets, we see the mix of Generation 5 and Generation 6 Isilon nodes, the two InfiniBand switches which service the Cluster's back-side (those are fed by the bright blue and bright red power cords), plus a somewhat clearer view of the ProfiShark, sitting on top of a stack of Isilon nodes.

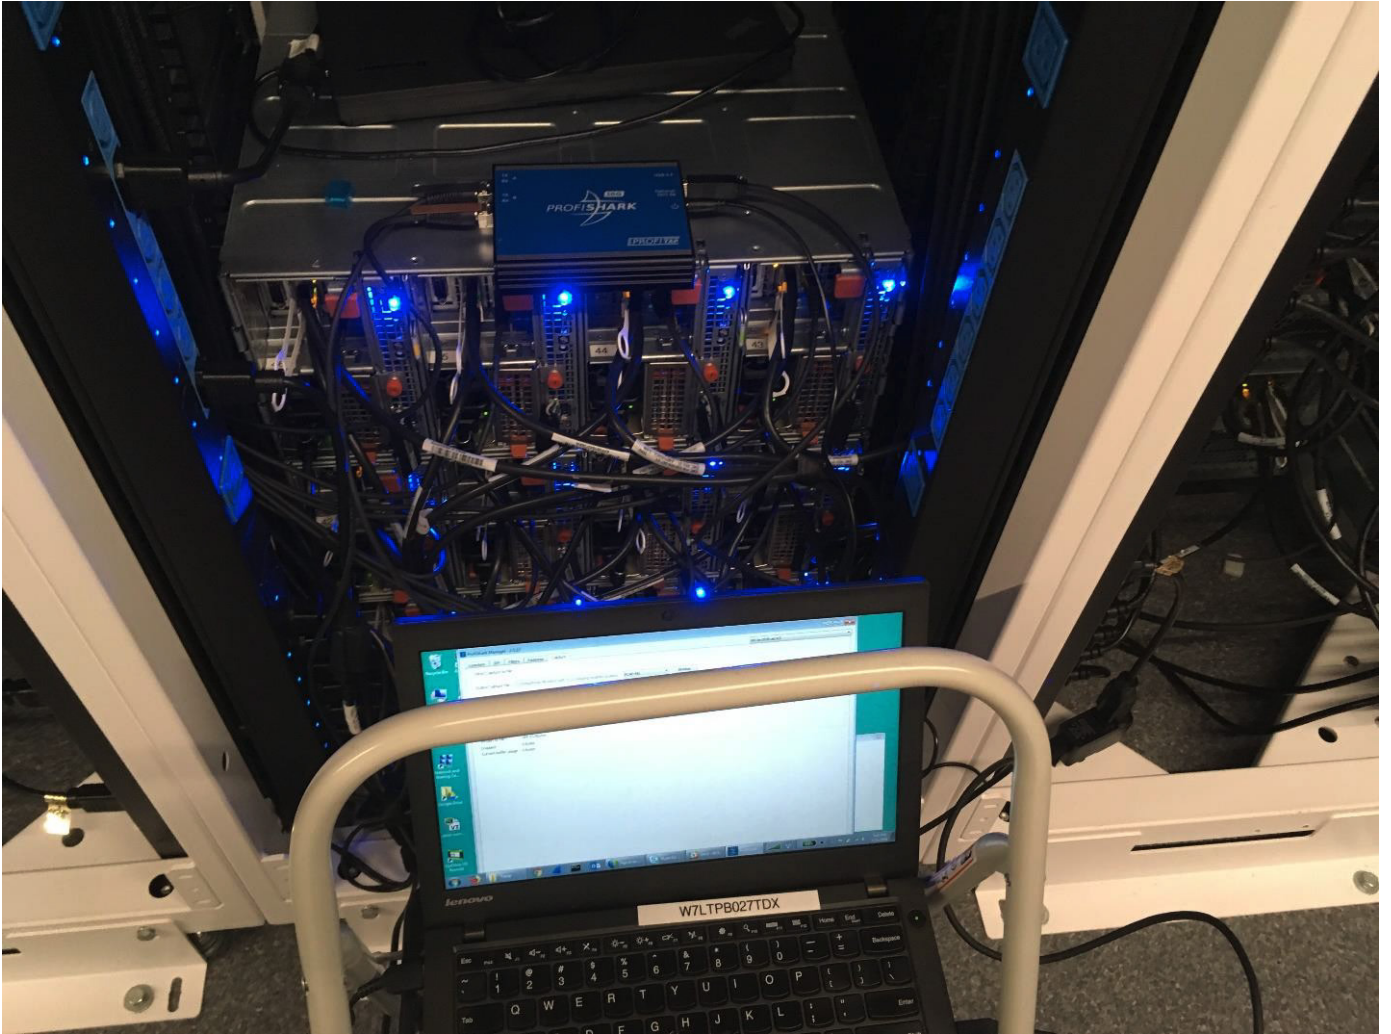
Laptop on Stool

Here we see the ProfiShark more clearly.

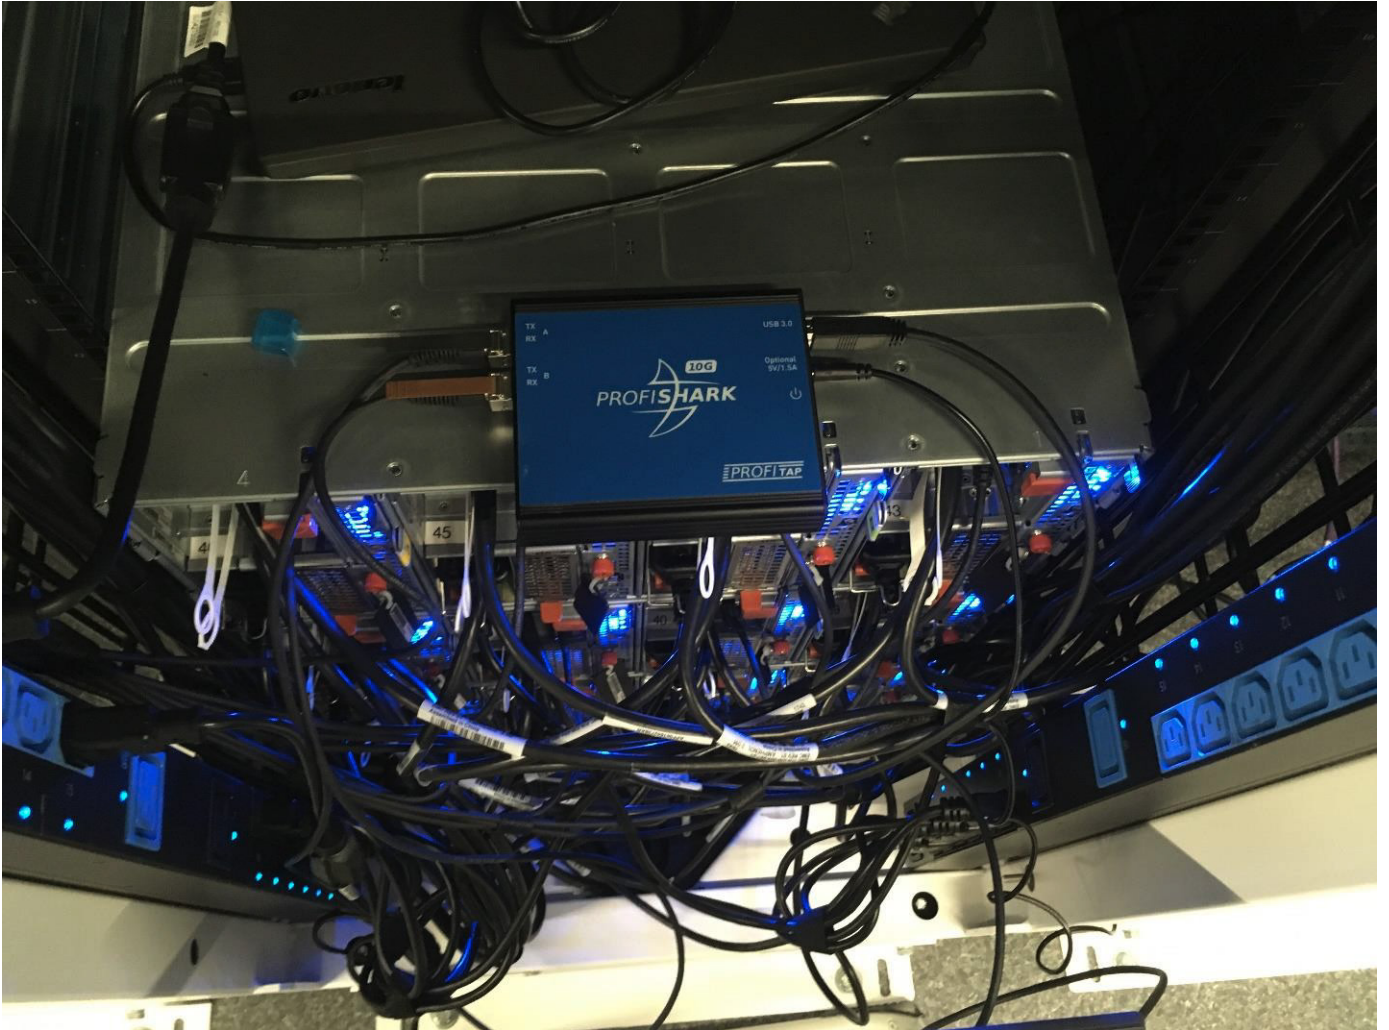
ProfiShark Close-up

And here we focus on the ProfiShark. Inserted into its left-hand side are the (2) 10G twinax cables which place it in-line with one of the Isilon Nodes below. On the right-hand side are inserted the USB cable connecting it to the laptop, along with a power cord attaching it to a wall-wart power supply. This power supply isn't a requirement – the ProfiShark will power itself from the USB link to the laptop. However, I wanted to be able to grab the laptop and walk away with it, leaving the ProfiShark behind. If I did that without first providing external power, then the ProfiShark would go dark and the Isilon Node would be disconnected from the network.
